CONSERVATION REPORT

Ballyglunin Railway Station

Completed by Plan A Design, Architectural Design and Conservation.

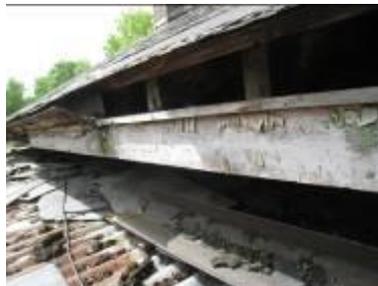
Fig. 01

Historic photographs of the building show an overhanging verge, where the roof extended over the gable to give further protection and was finished with a barge board, which appeared to be painted. This feature is no longer visible as the verges and eaves have been boxed out in bulky timber detail. Opening up works are required to establish if the barge board is still in place. The eaves also have a deep overhang with a horizontal slab or soffit board fitted to overhang the top of the wall. The rafter feet were not boxed in but rather a timber eaves bracket covered the lower half of the rafter feet, and the cast iron guttering rested on this, see fig. 1. The lower half of the bracket formed a fascia protecting the lower half of the rafter feet.

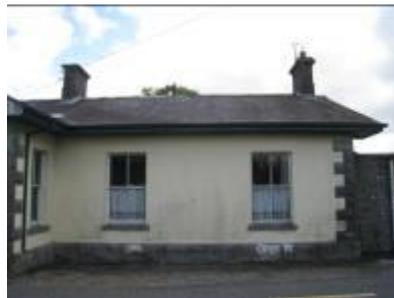
Fig. 02

When looking at the front of the building to the right hand side, see *fig. 02*, a length of gutter runs along the porch at the front door, this then turns and runs along the front of the building. This is mirrored on the opposite side. It is difficult to tell if this is original without access but it appears to match the original profile however it ends at both gables with a gutter stop. In the historic photos it appears that the gutter once returned for approx 400mm around the gable. It is possible however that this return was cut off when the eaves were boxed out. The front gutter appears in good condition with only small areas suffering from corrosion. Some vegetation and growth is evident. Two non original down pipes are fitted on either side of the front porch. These are square in profile and end at the top of the stone plinth. These were probably put in position when the down pipes at the gables were removed.

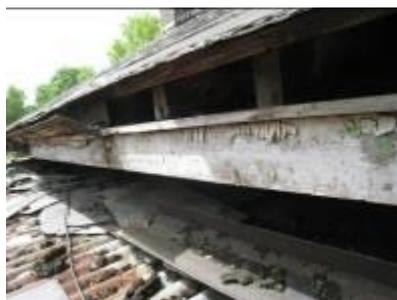
Fig 03

The cast iron gutter to the rear elevation is in poor condition and is severely corroded in sections. Some sections are not secured in position and are resting on the platform canopy, thus leaving the rafter feet exposed, see *fig 03*. It appears that the gutters were fixed directly to the rafter feet and rest on a fascia board rather than being fixed to the fascia board. During site inspection it was noted that the gutters are fitted almost behind the slates and it is most likely in this position that rain running off the roof would over shoot the guttering altogether and land on the platform roof. As with the front elevation this gutter once returned around the gable before the eaves were boxed in.

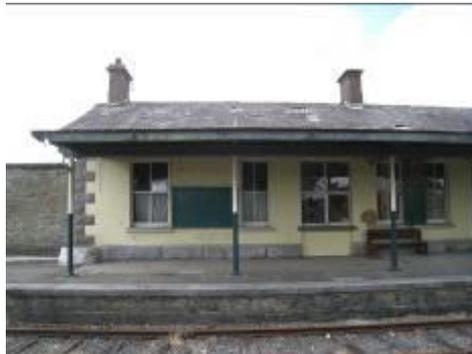
Fig 04

There is no rainwater goods associated with the platform canopy, see fig. 04. The corrugated roof covering extends over the timber work and water runs off this roof and onto the railway tracks.

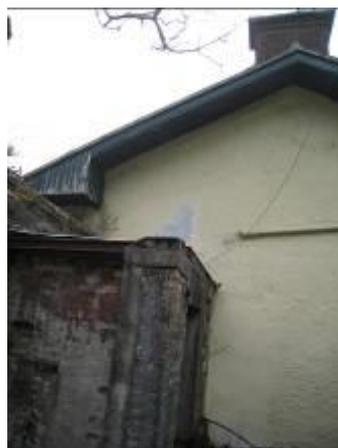
Fig 05

A section of cast iron pipe remains fixed horizontally to the north gable, see fig. 05 & 06, however since the boxing out of eaves this is no longer connected to the gable down pipes which have been removed. From historical photos, see fig 07 & 08, it is assumed that this cross pipe once took water from the front gutter and connected it to a down pipe at the platform end of this gable wall. The pipe has been maintained and appears in generally in good condition. The collars or holderbats and bolts that fix the cross pipe to the building façade are corroded and staining slightly.

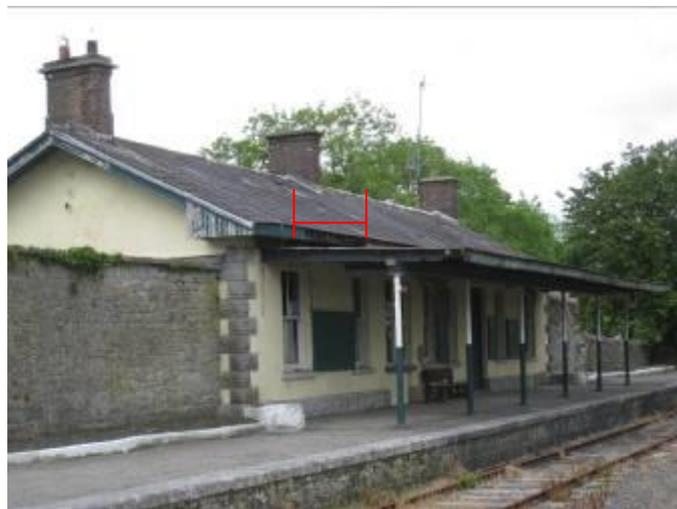
Fig 09. Section of missing gutter to rear requiring 'like for like' replacement.

If sections of guttering to rear have become too damaged to repair they may need to be replaced *see Fig 09*. Fixing of gutters require closer inspection following installation of working platforms as gutter brackets do not appear to have been used, this is to be agreed on site.

If full sections of gutters require replacement it is important that the new material is in keeping with the original to prevent the risk of galvanic corrosion. Traditional techniques should be used to shape and assemble new sections to ensure a like for like replacement, which can be date-stamped to distinguish them from original material. New castings should be cast using traditional green sand mould technique. Original ironwork can be used to create a template for a new pattern to be made in timber or resin. Surface finish and detailing should be of good quality. Replacement subject to approval of sample by conservation consultant.
